Arborist report for Adam and Jessica Masten at 719 SW 57<sup>th</sup> st. Corvallis, Oregon

Prepared by Matthew Sanchez, ISA Certified Arborist PN 7830A

10/7/2015

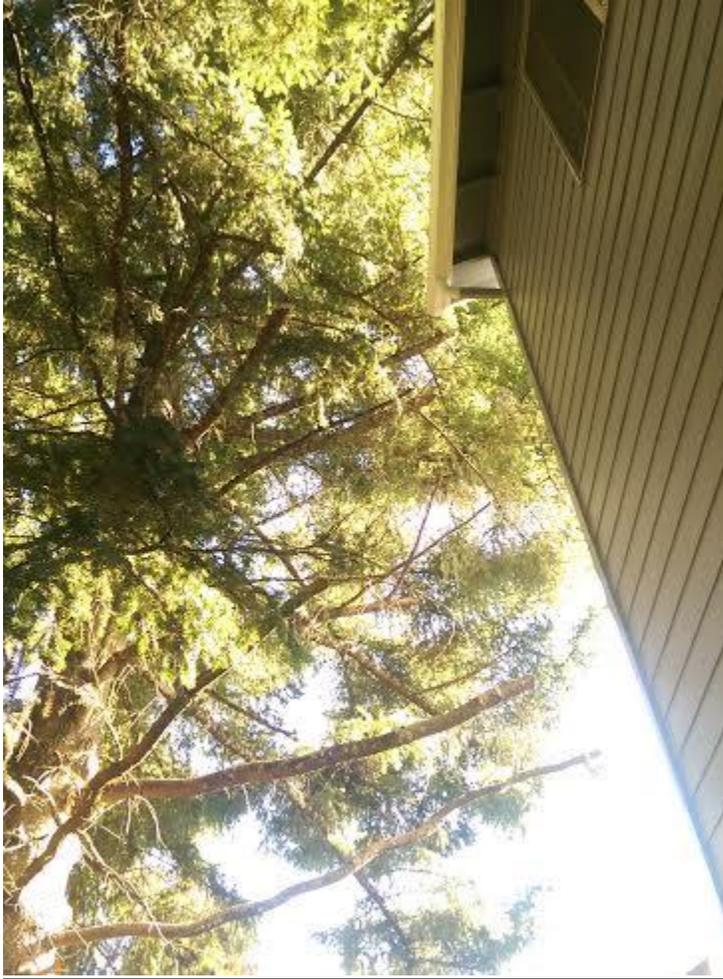
Tree "A" is a 19.5" Douglas fir, it is 12' from the home. This particular tree needs to have all the branches that were improperly cut for construction purposes properly pruned. In addition removal of dead wood and a general structure clearance are also recommended. It would be in the homeowner's best interest to also remove excessive bark dust build up from around the trunk of the tree to prevent potential damage. This tree is healthy and in good condition, there are no signs of failure at this time.

Tree A This photograph depicts the improper pruning of the tree branches as well as the close proximity to the house.

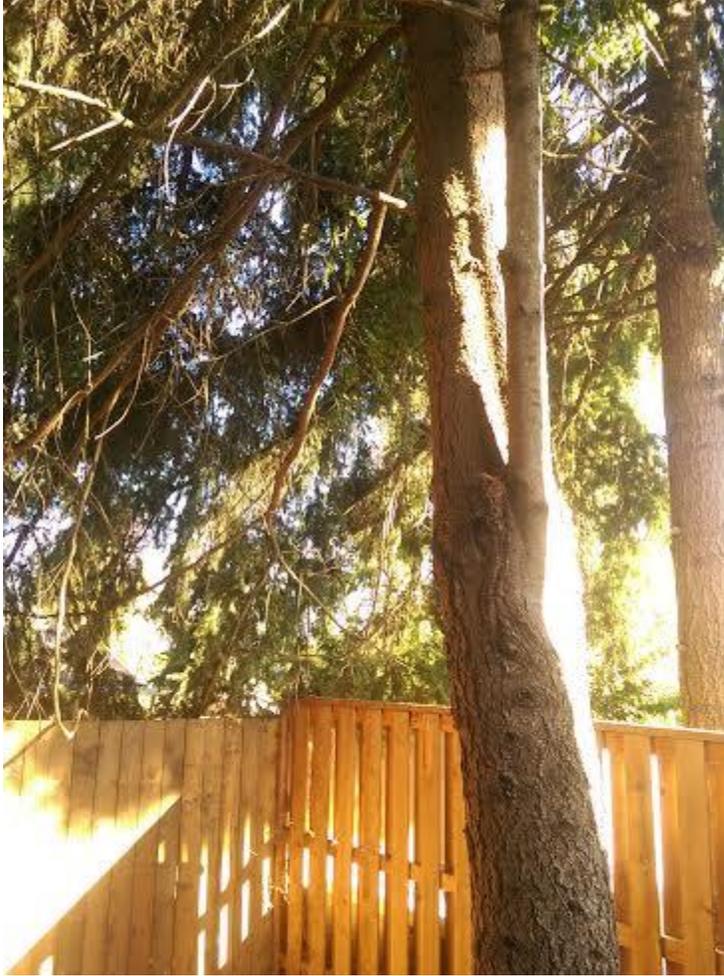
Tree "B" is a 13.5" Douglas fir, it is 17' from the home. Recommended action for this tree is to remove both failed attempts of a codominant union, remove dead wood, and remove wisteria that has grown from a neighboring property. This tree appears to have endured storm damage at one point in time. It is important for a climber to inspect this area and either choose a new top, or reduce the crown to a lateral branch. It would be in the homeowner's best interest to also remove excessive bark dust build up from around the trunk of the tree to prevent potential damage. This tree is in healthy and good condition, there are no outstanding signs of failure at this time.

*Tree B This photograph depicts an attempted codominant stem, that is suggested for mitigation.*

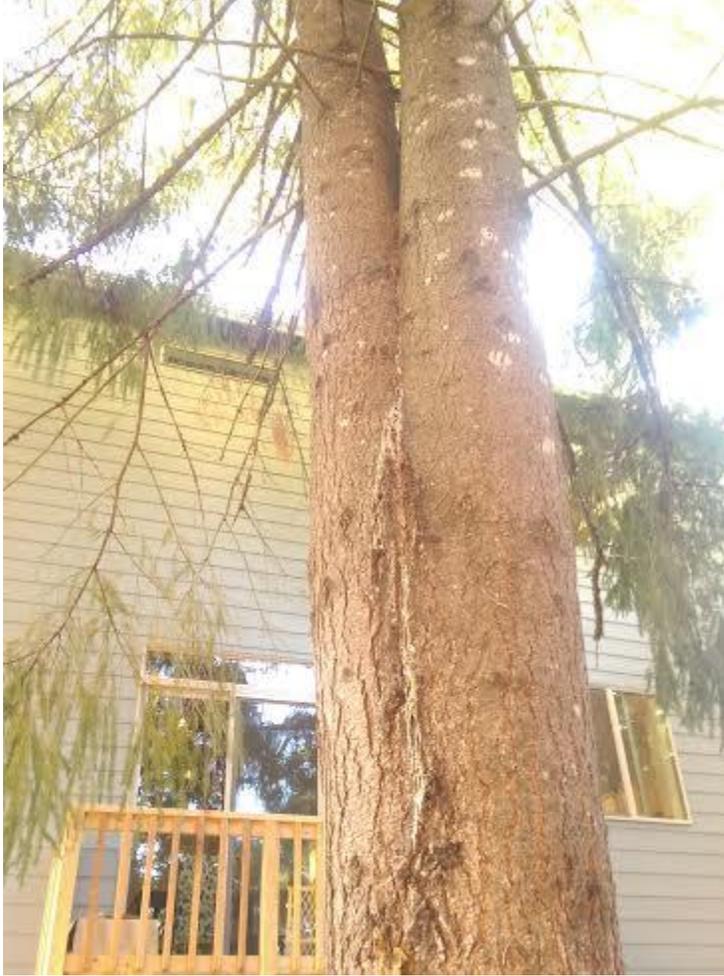
Tree "D" is a 16" Douglas fir, it is 16' from the home. This tree has a codominant union with roughly 6' of inclusion with sap weeping on the east and west side. The predicted failure of this tree is aimed at the home in the SW direction. It is my recommendation to remove this tree to reduce the potential for failure, it is in my opinion, a mishap that this tree was selected for survival when constructing the home. The monetary value of this tree is \$355, and it will be replaced within 180 days with an approved native species. My recommendation for replacement is *Acer circinatum*, Oregon vine maple, this species is excellent at growing in the shade of Douglas firs and is one of the only natives that would best fit this site. Removing the stump to plant this species is unnecessary unless the homeowner wishes this task, the maple could be planted elsewhere.

*Tree D This photograph depicts the east side of the large codominant fir with a ~6' bark inclusion that is swollen and weeping sap.*

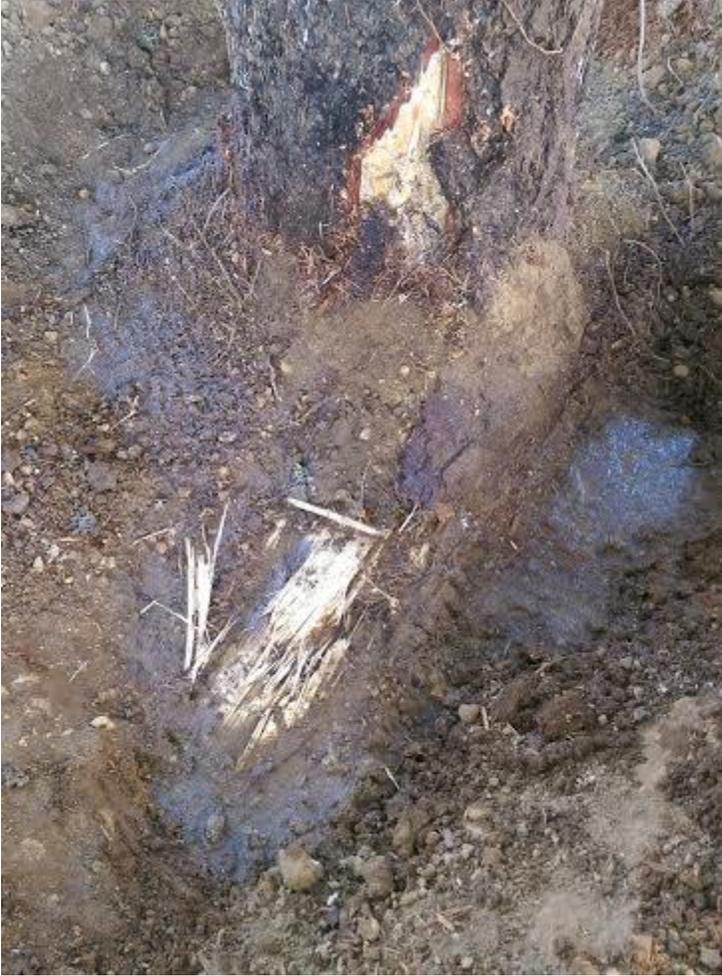
Tree "E" is a 13" Douglas fir, it is 22' from the home. This tree has been negatively impacted by development and is not fit for this site. As a result of installing utilities on this property it appears that the excavator ran into the trunk and cut roots. This tree is currently growing with a lean to the east and the roots that were badly damaged are on the west, encouraging the destabilization of the tree. Removing this tree before it fails is highly recommended to avoid damages to neighboring property and the utilities. The monetary value of this tree is \$266, and it will be replaced within 180 days with an approved native species. My recommendation for replacement is *Acer circinatum*, Oregon vine maple, this species is excellent at growing in the shade of Douglas firs and is one of the only natives that would best fit this site. Removing the stump to plant this species is unnecessary unless the homeowner wishes this task, the maple could be planted elsewhere.

*Tree E This photograph shows a light root excavation done with a rake, water, and hands. The top wound is on the trunk and the bottom wound is of the roots.*

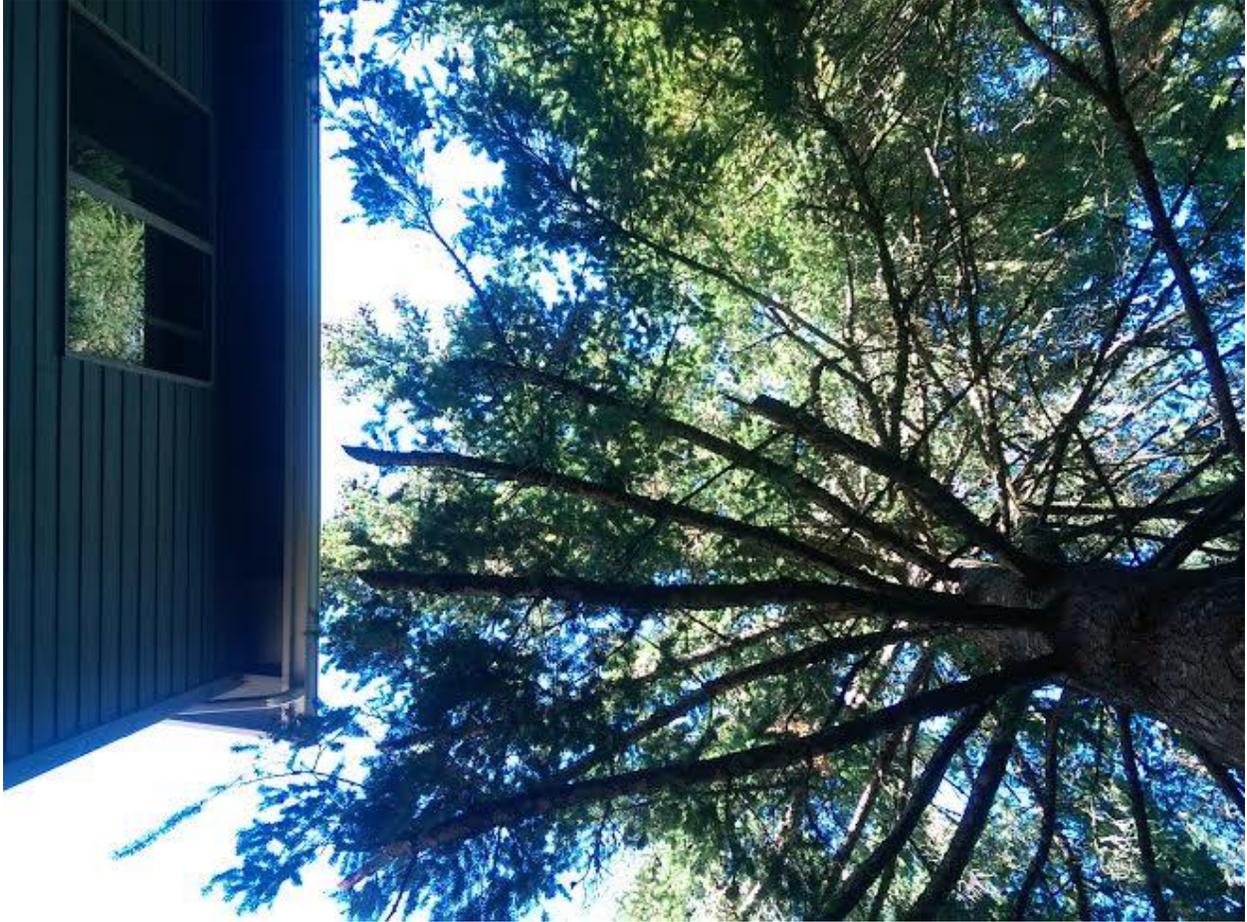
Tree "F" is a 19" Douglas fir, it is 13' from the home. This particular tree needs to have all the branches that were improperly cut for construction purposes properly pruned. In addition removal of dead wood and a general structure clearance are also recommended. It would be in the homeowner's best interest to also remove excessive bark dust build up from around the trunk of the tree to prevent potential damage. This tree is healthy and in good condition, there are no signs of failure at this time. In addition,

it is important to monitor the trunk for decay, the home has a deck that is 1' from the trunk of the tree, making me believe that some root disturbance occurred during construction.

*Tree F This photograph depicts the improper pruning of the tree branches as well as the close proximity to the house.*
