CHAPTER 12

WATERSHED PLANNING AND ANALYSIS: MARYS RIVER

Figure 12-2. Watershed Photos

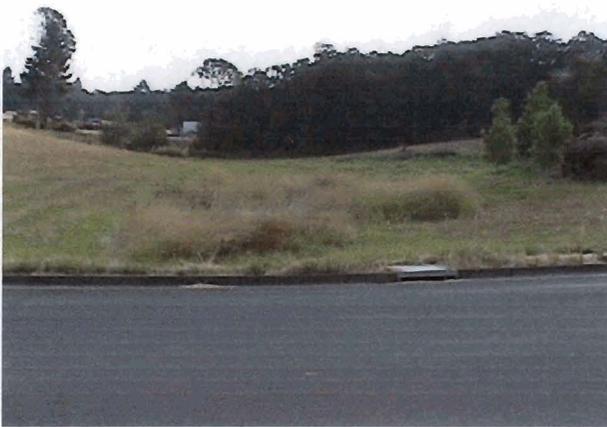
All three Marys River drainages that were studied have moderate slopes upstream of Brooklane Drive, as shown in Figure 12-2, Photo 1. The central and western drainages become flatter downstream of the culvert. The eastern drainage contains a short, steep section of channel downstream of the culvert before it reaches the flatter floodplain.

Photo 1. Uphill from middle culvert at Brooklane Drive

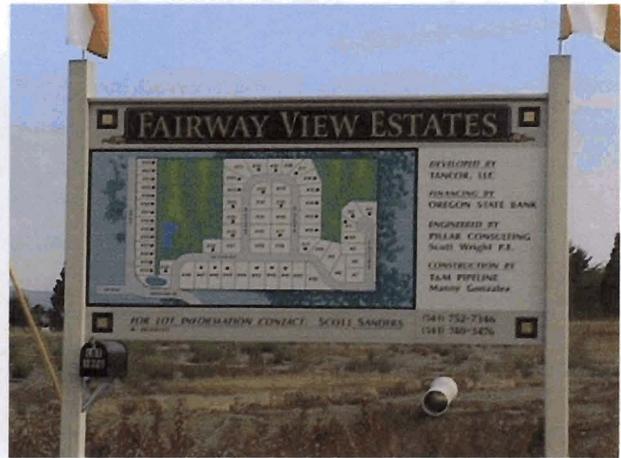
The Marys River drainages are currently undergoing significant development. As shown in Figure 12-2, Photos 2 and 3, this development will add considerable impervious area to what has previously been open space and a limited number of homes on large lots. The three culverts examined did not appear to have capacity problems, but the east culvert (Figure 12-2, Photo 4) has a steep slope. The steep slope leads to high velocities, which has caused erosion problems downstream of the culvert in spite of a flow dissipater at the culverts downstream end (Figure 12-2, Photo 5). Problems with erosion have also led to the installation of extensive riprap in the Park Estates development occurring farther to the east at the bottom of the slope (Figure 12-2, Photo 6).

Photo 2. Marys River area is developing rapidly

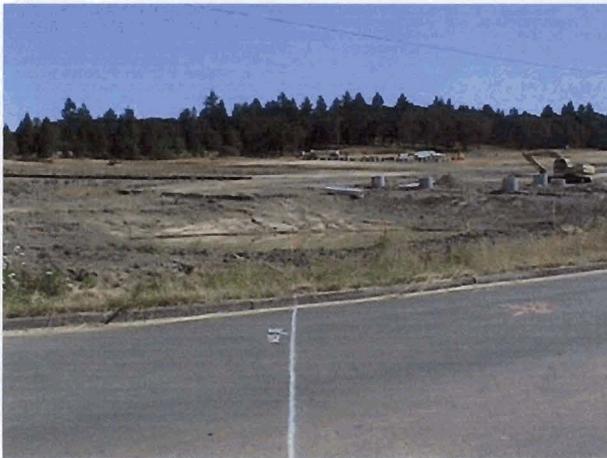
Photo 3. Uphill from east culvert, line of new culvert under Brooklane Drive

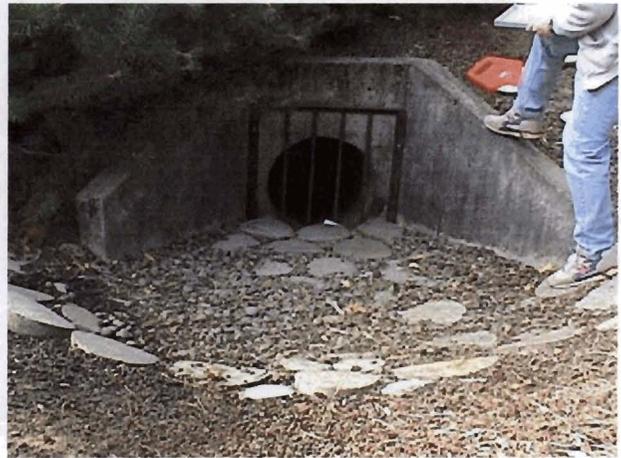
Photo 4. Entrance to east culvert in private yard

Field Observations: The main path for stormwater runs through a private yard and enters a culvert under Brooklane Drive. The culvert has a steep grade, resulting in high velocity discharges. A small concrete wall has been incorporated into the culvert apron at its downstream end to dissipate the force of the flow. However, soil is eroding underneath the culvert apron and in the downstream channel.

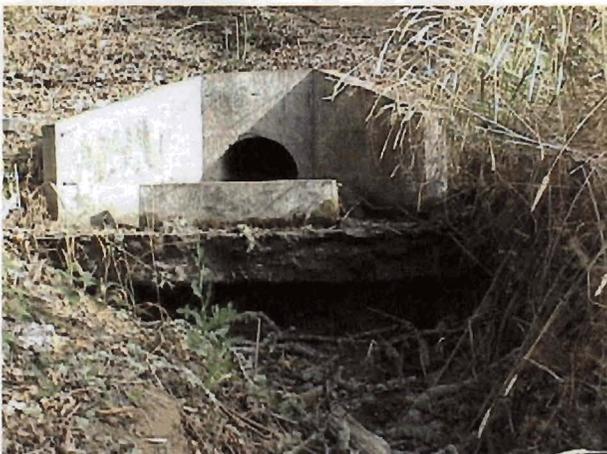
Photo 5. Erosion at east culvert outlet

Modeling Results: Modeling showed no capacity problems for the 10-year storm event. However, the steep culvert discharges high velocity flows, estimated at 5 feet-per-second during the 2-year storm event, causing erosion downstream.

3) High velocity discharges causing erosion downstream of culvert.	a. Extend culvert to flatter area (approximately 100 feet) and install large flow dissipater at this point.	Short-term	
Park Estates Basin	1) Increased imperviousness due to development.	a. Preserve vegetated channel system through conservation easements to mitigate effects of increased flows and pollutants.	Short-term

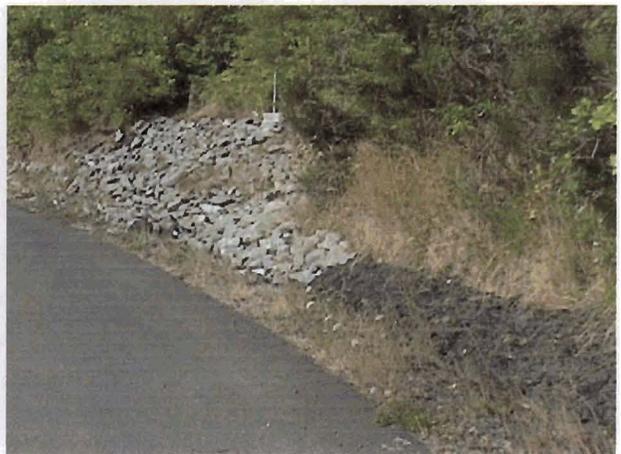
Photo 6. Park Estates ditch with riprap

Field Observations: The Park Estates development is located at the base of the slope below Oak Lawn Memorial Park. A culvert, apparently from the cemetery, discharges to a riprap-lined ditch before entering the pipe system. Most of the development has a moderate to flat slope.
