## CHAPTER 13

### WATERSHED PLANNING AND ANALYSIS: SOUTH CORVALLIS

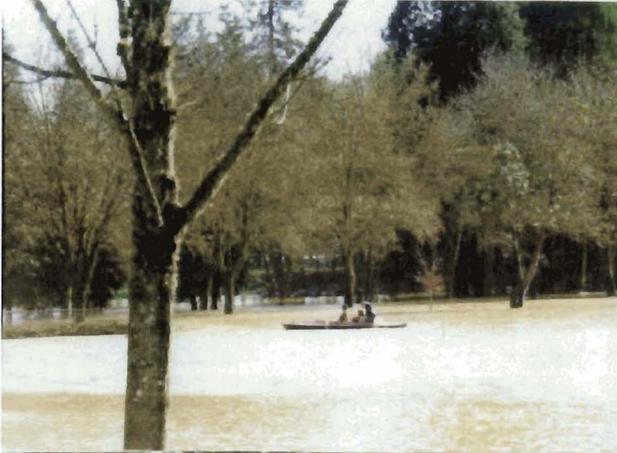
South Corvallis has a long history of flooding problems, most recently in February 1996, as shown in Figure 13-2, Photo 1. The South Corvallis Drainage Master Plan (SCDMP) was completed in 1996 (KCM, 1998). The study area for the SCDMP focused on the areas south of Goodnight Avenue. The SCDMP reported the existing land uses to be mainly farming, with future uses focused on light industrial. The existing airport land use will remain as airport land in the future.

Photo 1. 1996 flooding in Avery Park.

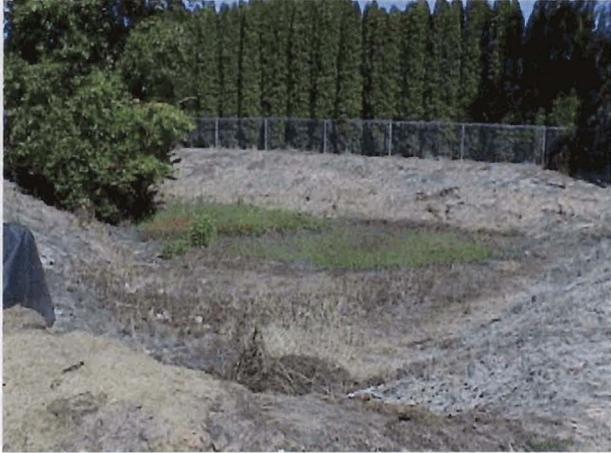
Photo 2. Detention pond near Goodnight Avenue.

**Field Observations:** The diversion structure located between Hathaway Drive and the mobile home park contains an orifice plate for detaining higher flows. Water backed up behind the plate is stored in the piped system and the detention pond located just to the east. As designed, the pond acts as a surge pond. The pond margins are mowed regularly and grass clippings are dumped on the banks.

3) Public detention pond located on private property acting as surge pond.	a. Surge pond is not required. City should investigate other use for this land.	Long-term
Mill Race Basin – Willamette River to Evanite Culvert	1) Good reach for community stewardship. Top of bank lacks shade trees.	a. Community involvement opportunity for tree planting effort.	Short-term
Mill Race Basin – Evanite Culvert to Highway 99	1) Good reach for community stewardship. Top of bank lacks shade trees.	a. Community involvement opportunity for tree planting effort.	Short-term

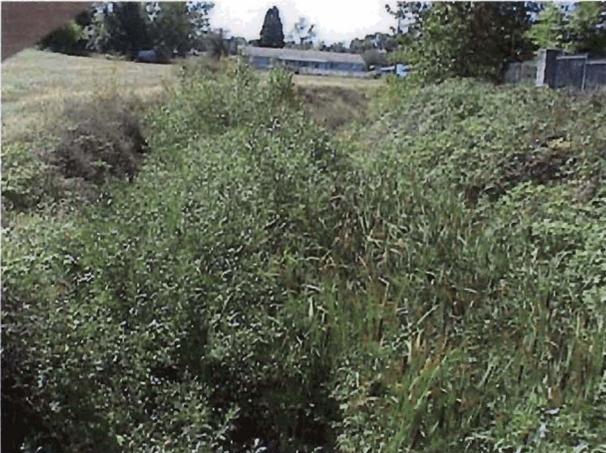
Photo 3. Channel upstream of Crystal Lake Drive.

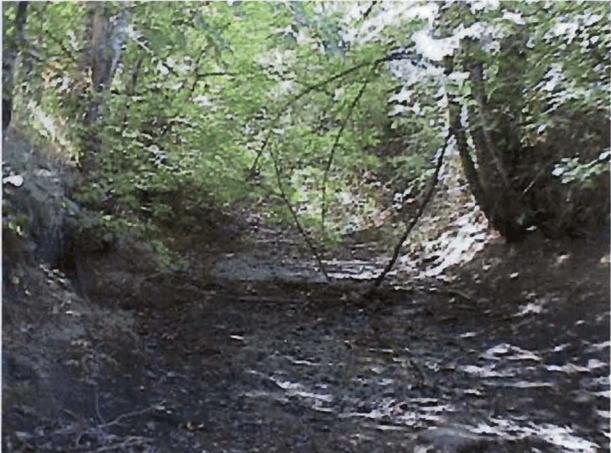
Photo 4. Channel upstream of Atwood Avenue.

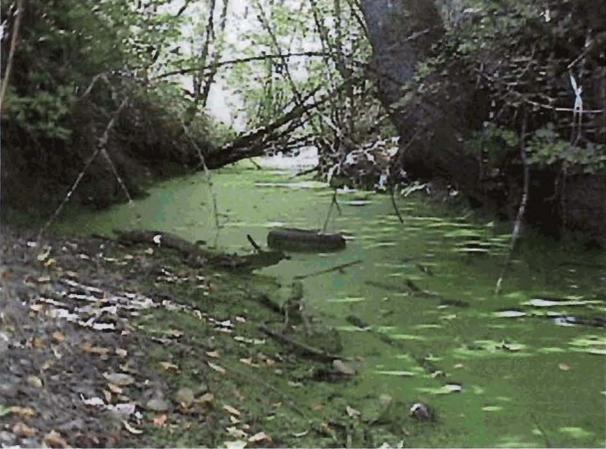
Photo 5. Stagnant water in the Mill Race upstream of Hwy 99.

Field Observations: A low spot in the channel just upstream of Highway 99 contains a long length of stagnant water with plentiful algae growth. An abundance of trash throughout this reach indicates that dumping is a problem. The stream banks show signs of lateral erosion. The outfall pipe from Marysville Golf Course discharges into the Mill Race drainage basin from under Allen Street. The

Reach	Abridged observations	Recommended activity	Timing
		b. Develop citywide ordinances requiring treatment of parking lot runoff.	On going
	5) Stagnant water with algae.	a. Increase summertime flows through the Mill Race. (See last Mill Race recommendation in table.)	Long-term

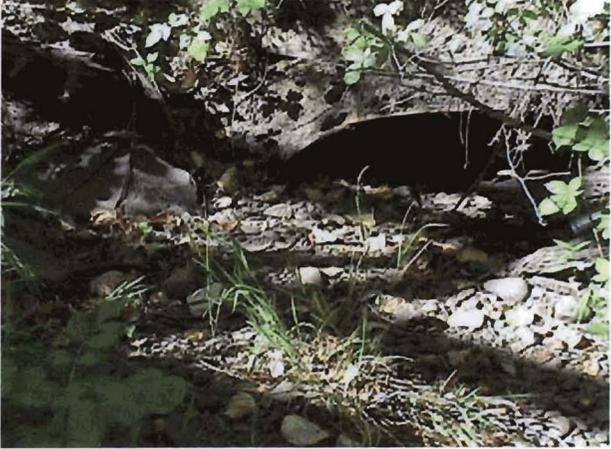
Most of the stream reaches have a tree canopy that provides shade. The downstream reach of the Mill Race drainage basin lacks a tree canopy, but does contain numerous small willows that limit channel erosion, as shown in Figure 13-2, Photo 3. The reaches farther upstream have better shade but more problems with channel erosion. During summer months, water in the channel is not hydrologically connected to either the Willamette or the Marys Rivers. The reaches have alternate sections of dry channel, as shown in Figure 13-2, Photo 4, with stagnant pools of water, as shown in Figure 13-2, Photo 5. The upstream end of the Mill Race drainage basin has large trees for shade and woody debris in the channel. It also has erosion problems and a culvert that is almost completely filled in with sediment, as shown in Figure 13-2, Photo 6.

Photo 6. Culvert at Allen Street filled with sediment.

Field Observations: The culvert under Allen Street is almost completely clogged with sediment at the downstream end; only the top one-foot remains free. The metal culvert is corroded and appears to be sagging under the road. Large trees shade the channel upstream of Allen Street. A number of logs are present along the channel bottom, representing potential fish habitat. However, the bottoms of the streambanks are eroding.

2) Culvert under Allen Street is filled with sediment and structurally failing.	a. Replace culvert.	Short-term
	3) Lower edge of streambanks are failing.	a. Work with Benton County to stabilize with structures along stream banks that also provide habitat value. These can be worked in with large woody debris already in this stream reach.	Long-term

Mill Race Basin – Allen Street to Marys River	2) Replace culvert.	9,100	455

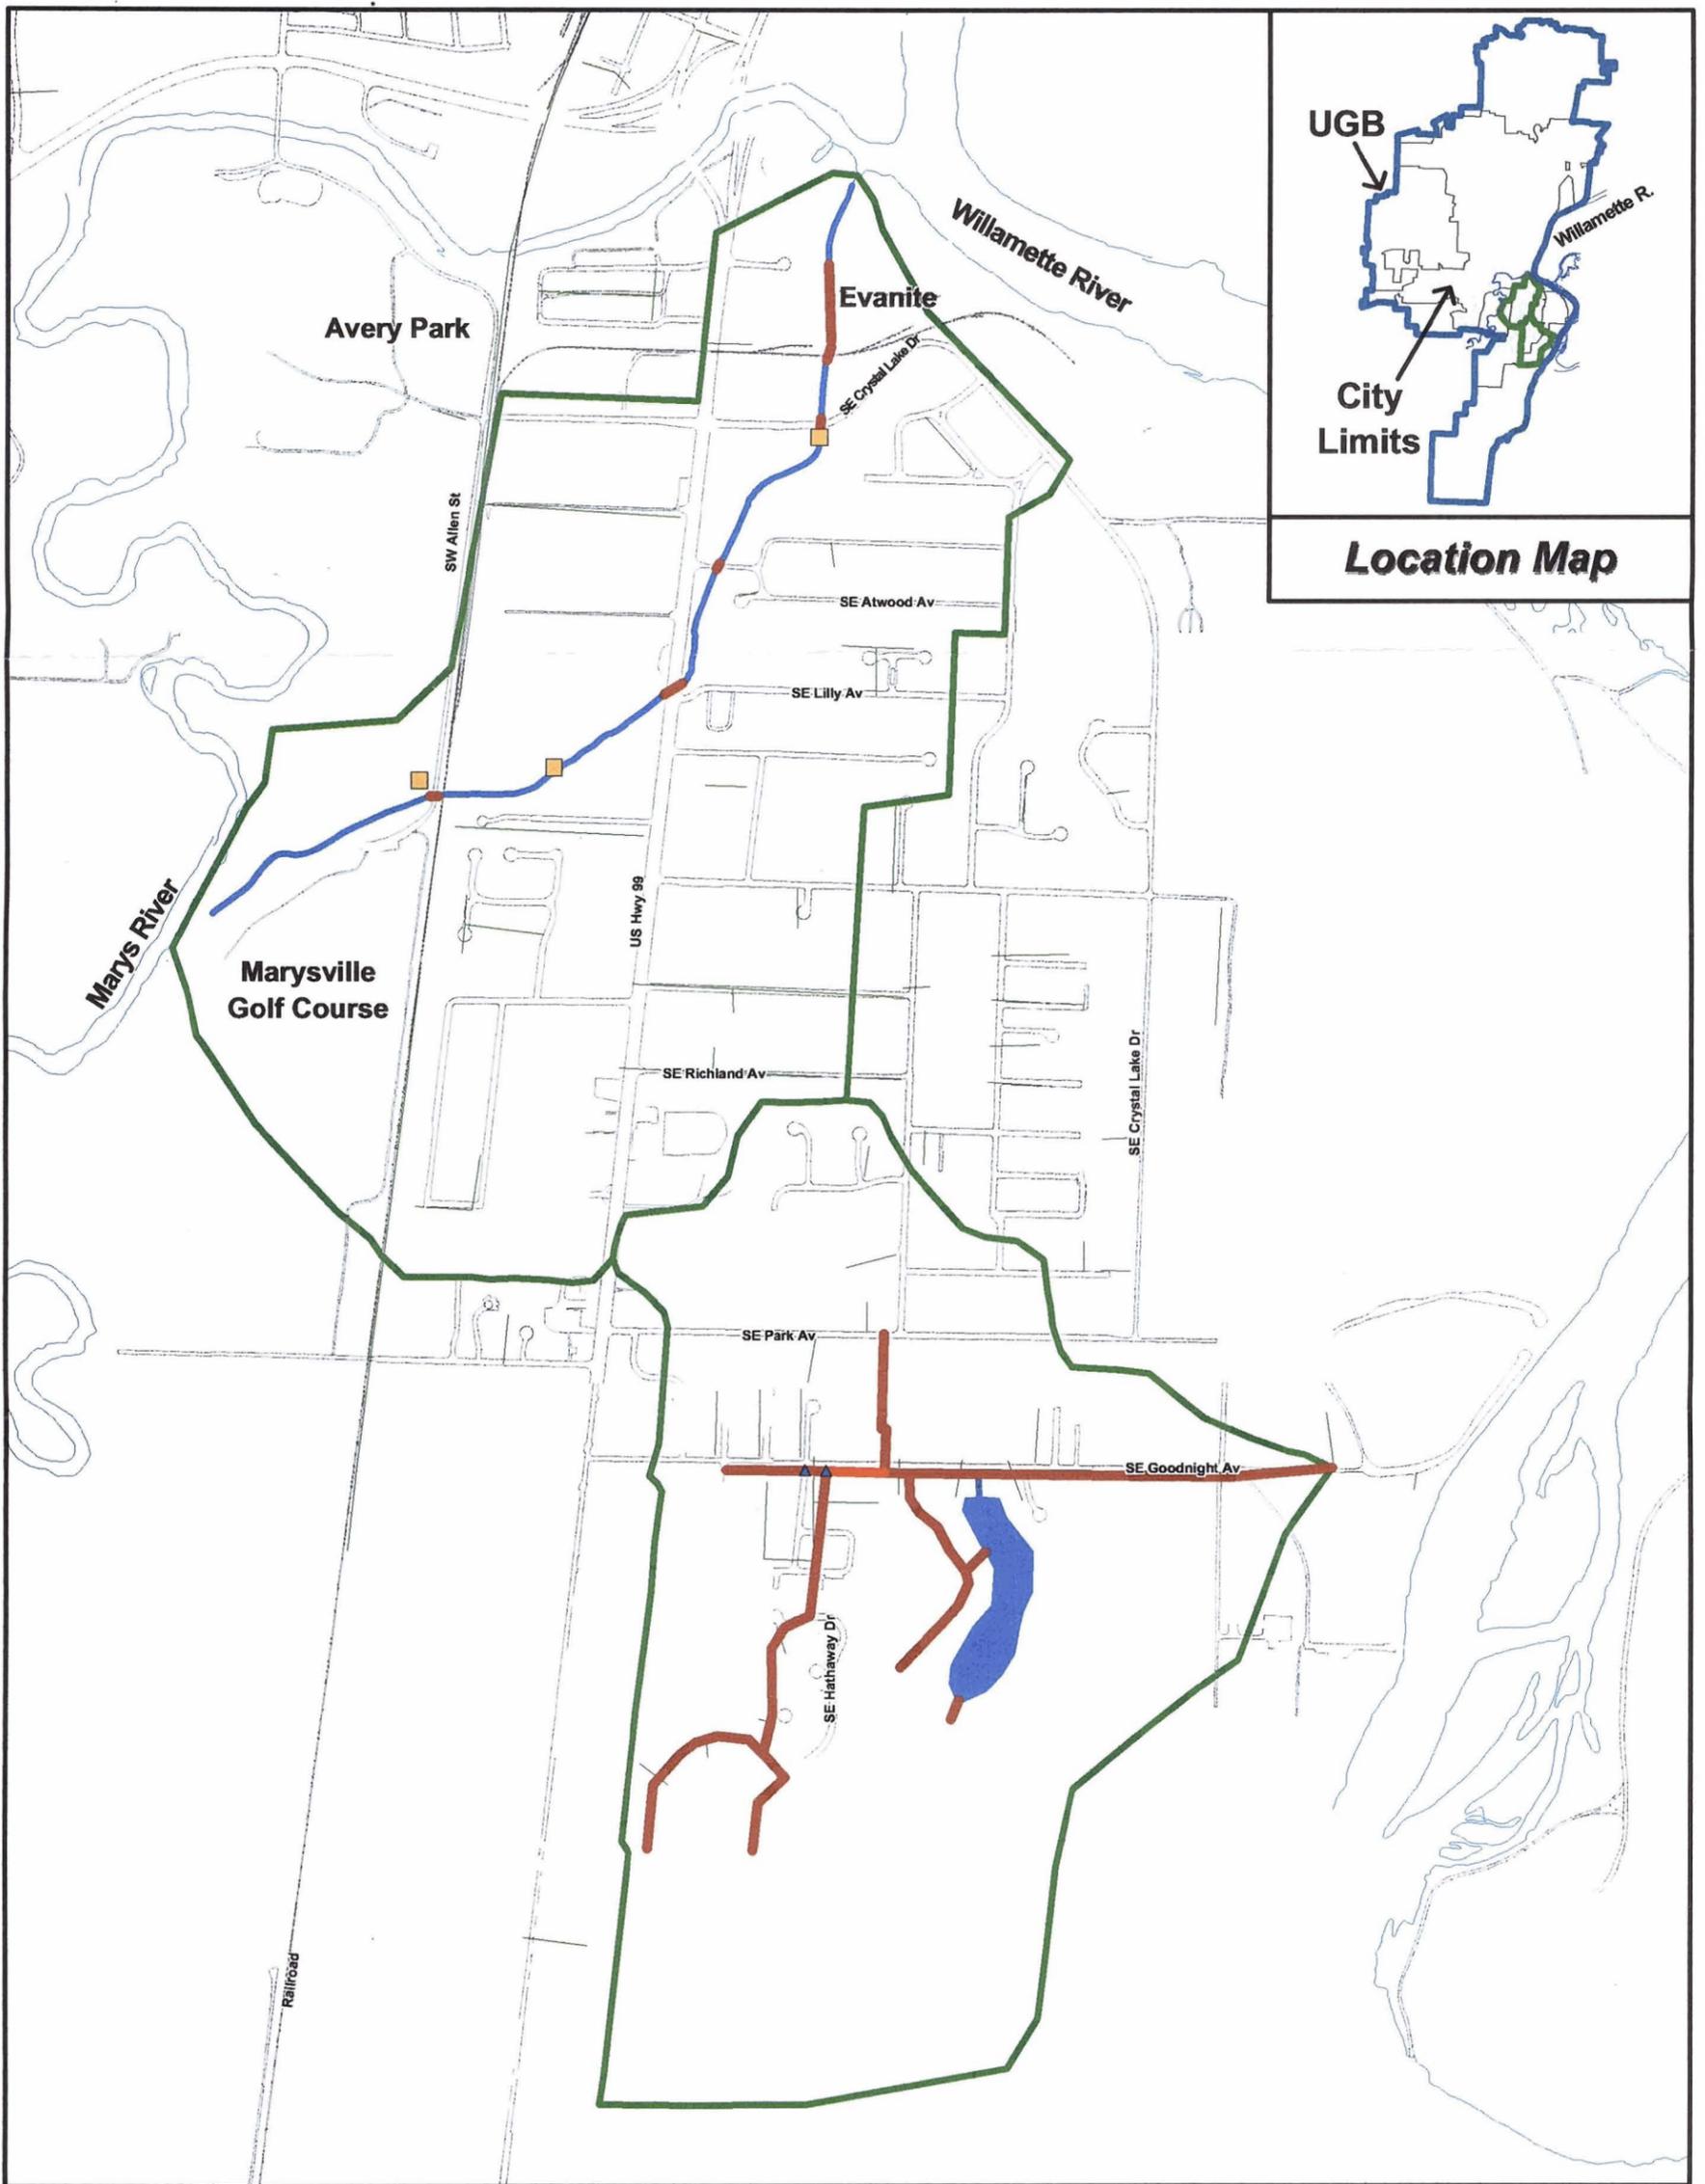
**Figure 13-3 South Corvallis Problem Areas**

The problem areas identified in the following sections are shown in Figure 13-3.
