## CHAPTER 7

### WATERSHED PLANNING AND ANALYSIS: SQUAW CREEK

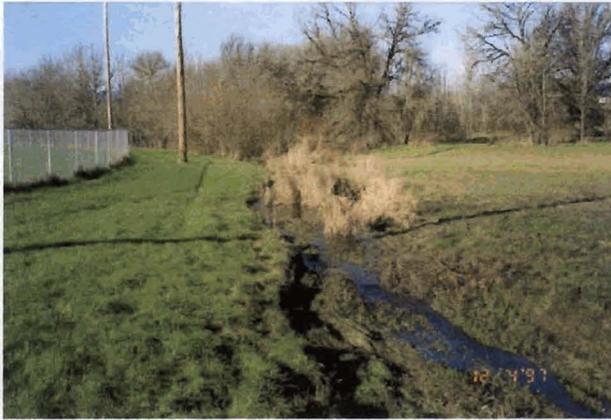
Photo 1. Sunset Park ball fields under normal conditions.

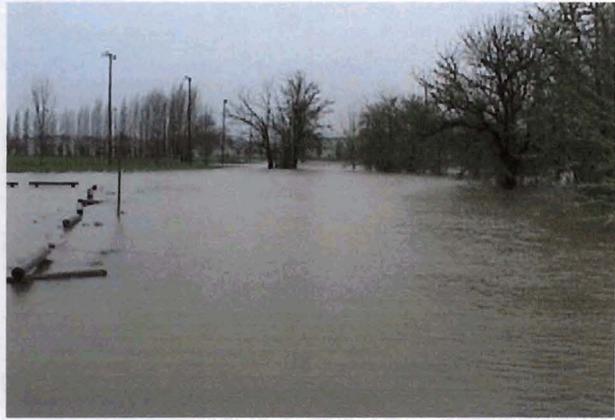
The Squaw Creek watershed is relatively flat and erosion does not appear to be a significant issue. The low gradient has resulted in extensive areas lying within the 100-year floodplain and a large number of wetlands. Flooding is a concern along Squaw Creek. Figure 7-2, Photo 1, shows a low-lying area at Sunset Park with its small channel during normal conditions. Figure 7-2, Photo 2, shows approximately the same location during the February 1996 floods. The 1996 events also caused flooding further downstream at Knollbrook Place as shown in Figure 7-2, Photo 3.

Photo 2. Flooding at Sunset Park ball fields

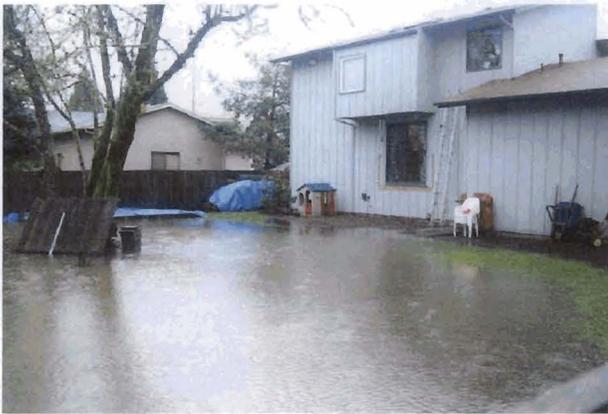
Photo 3. Flooding downstream of Knollbrook Place

5) Large storms cause flooding near Knollbrook Place. Field studies show the channel capacity is limited due to tight meanders and large amounts of woody debris above normal water levels. Hydraulic modeling shows flooding near Knollbrook Place.	a. Create overflow channel for high flows along north side of channel.

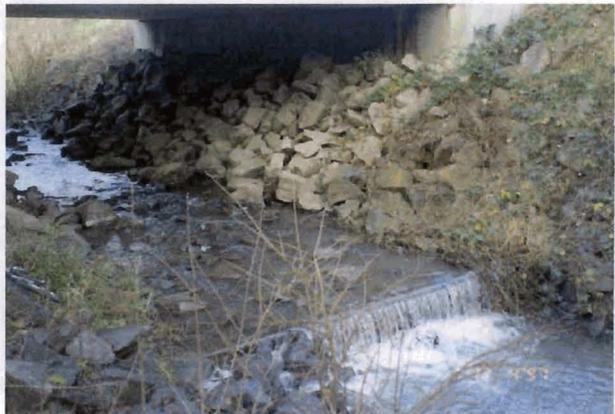
Other issues within Squaw Creek include fish habitat and passage issues, such as the riprap barrier at Brooklane Drive, Figure 7-2, Photo 4. The Squaw Creek watershed also includes extensive parks, bike trails, and open spaces. There are pollution concerns (bacteria from duck wastes) in the Starker Arts Park (Figure 7-2, Photo 5). Recent maintenance efforts have cleared some of the accumulations of debris downstream of Knollbrook Place that impeded flows (Figure 7-2, Photo 6).

Photo 4. Fish passage concern at Brooklane Drive

Field Observations: A concrete structure near the Brooklane Drive bridge creates a 4-foot vertical drop in the channel that is a fish passage barrier. The stream channel has a number of sharp meanders in the area near Reed Place that affect hydraulic capacity. Himalayan Blackberry is present at multiple locations on the banks and overbank areas. Debris at the top of the banks in the wooded area may impede flows during high-flow events. The channel has incised over time, exposing soft bedrock at a number of locations. Some lateral undercutting of the banks is apparent.

Fish passage is a concern at several locations within Squaw Creek. Under normal flow conditions, fish passage between Marys River and Squaw Creek is prevented by a 4-foot-high vertical wall in the channel near Brooklane Drive. Along the West Branch, the culverts beneath Philomath Boulevard and 53<sup>rd</sup> Street present a fish obstacle. City staff also identified potential problems with the culverts under the intersection of Western and Philomath Boulevards.

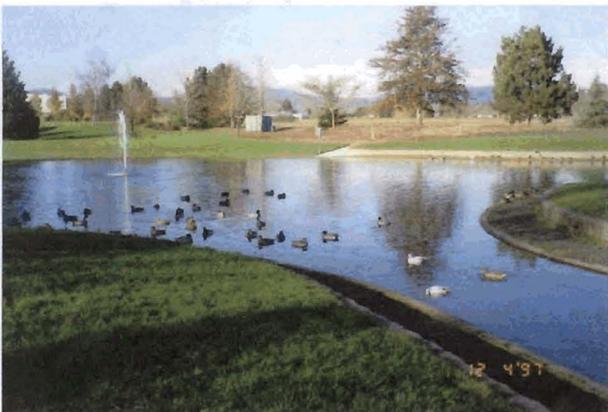
Photo 5. Bacteria concerns at Starker Arts Pond

City Staff Reports: The February 1996 storm caused high water along Country Club Drive from 49<sup>th</sup> Street to Martin Street. The duck population at Starker Arts Park pond may be the source of bacteria pollution. Pet waste may also be a problem along the bike path that runs parallel to the creek.

Reach	Abridged observations	Recommended activity	Priority
35 <sup>th</sup> Street to Country Club Place	1) Potential waterfowl pollution at Starker Arts Park Pond.	a. Convert the 100-foot long earthen ditch at pond outlet into a vegetated bioswale to provide filtration.	Short-term

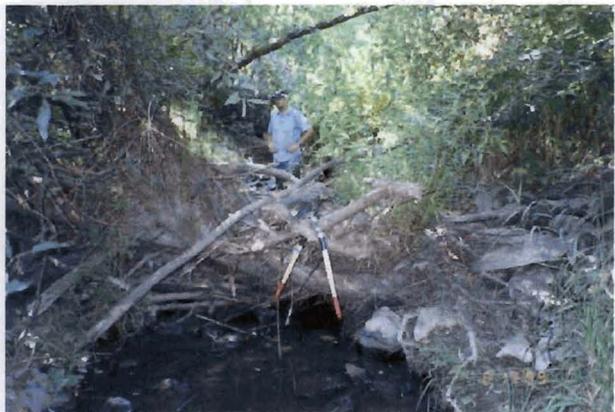
Photo 6. Stream blockage downstream of Knollbrook Place
